Otsego Lake Improvement Study and Management Plan Otsego County, Michigan

Provided for: Otsego Lake Association (OLA) Board

**Prepared by: Restorative Lake Sciences
Dr. Jennifer L. Jermalowicz-Jones, PhD
Water Resources Director
18406 West Spring Lake Road
Spring Lake, Michigan 49456
www.restorativelakesciences.com**

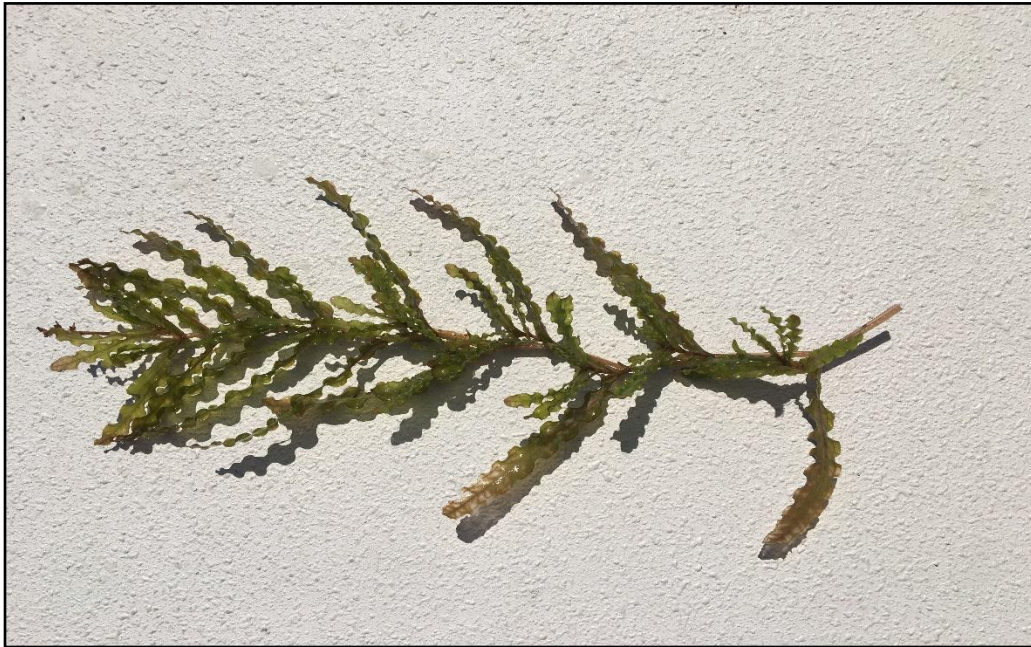
Figure 37. Curly-leaf Pondweed found at the South end of Otsego Lake (September 9-11, 2020).

There were approximately 0.5 acres of invasive Curly-leaf Pondweed found in a few areas at the southern region of the lake. Curly-leaf Pondweed (*Potamogeton crispus*; Figure 37) is an exotic, submersed, rooted aquatic plant that was introduced into the United States in 1807 but was abundant by the early 1900's. It is easily distinguished from other native pondweeds by its wavy leaf margins. It grows early in the spring and as a result may prevent other favorable native aquatic species from germinating. The plant reproduces by the formation of fruiting structures called turions. It does not reproduce by fragmentation as invasive watermilfoil does; however, the turions may be deposited in the lake sediment and germinate in following seasons. Curly-leaf Pondweed is a pioneering aquatic plant species and specializes in colonizing disturbed habitats. It is highly invasive in aquatic ecosystems with low biodiversity and unique sediment characteristics.

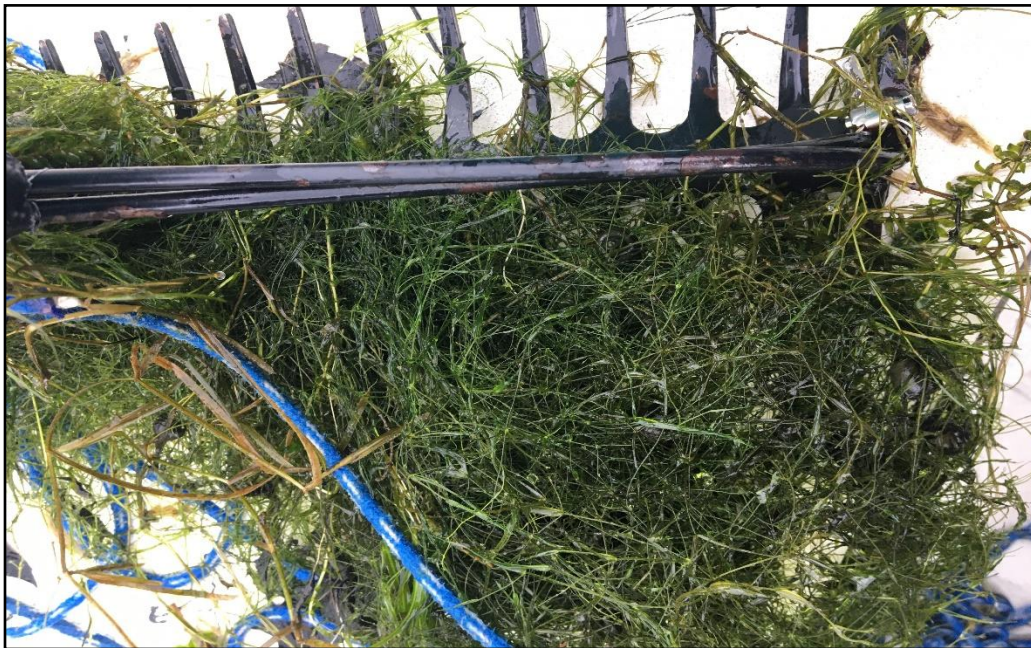
Figure 38. Starry Stonewort found in the Otsego Lake canals (September 9-11, 2020).

Lastly, approximately 2.8 acres of invasive Starry Stonewort (Figure 38) were found only in the canals. Starry Stonewort (*Nitellopsis obtusa*) is an invasive macro alga that has invaded many inland lakes and was originally discovered in the St. Lawrence River. The “leaves” appear as long, smooth, angular branches of differing lengths. The alga has been observed in dense beds at depths beyond several meters in clear inland lakes and can grow to heights in excess of a few meters. It prefers clear alkaline waters and has been shown to cause significant declines in water quality and fishery spawning habitat. Individual fragments can be transported to the lake via waterfowl or boats. Although it prefers alkaline waters, it can thrive in most clear waters and especially in shallow canals.

Because this activity may cause re-suspension of sediments (Nayar et al., 2007), increased turbidity and reduced clarity of the water can occur. Permitting requirements include the use of a turbidity curtain that reduce the transport of solids to locations outside of treatment areas and also help define areas where intensive aquatic vegetation removal efforts are being implemented. **This method may be feasible for small areas of milfoil removal once herbicides have reduced the cover, or small areas that become resistant to aquatic herbicides. It could also be used for the Starry Stonewort in the canals.**

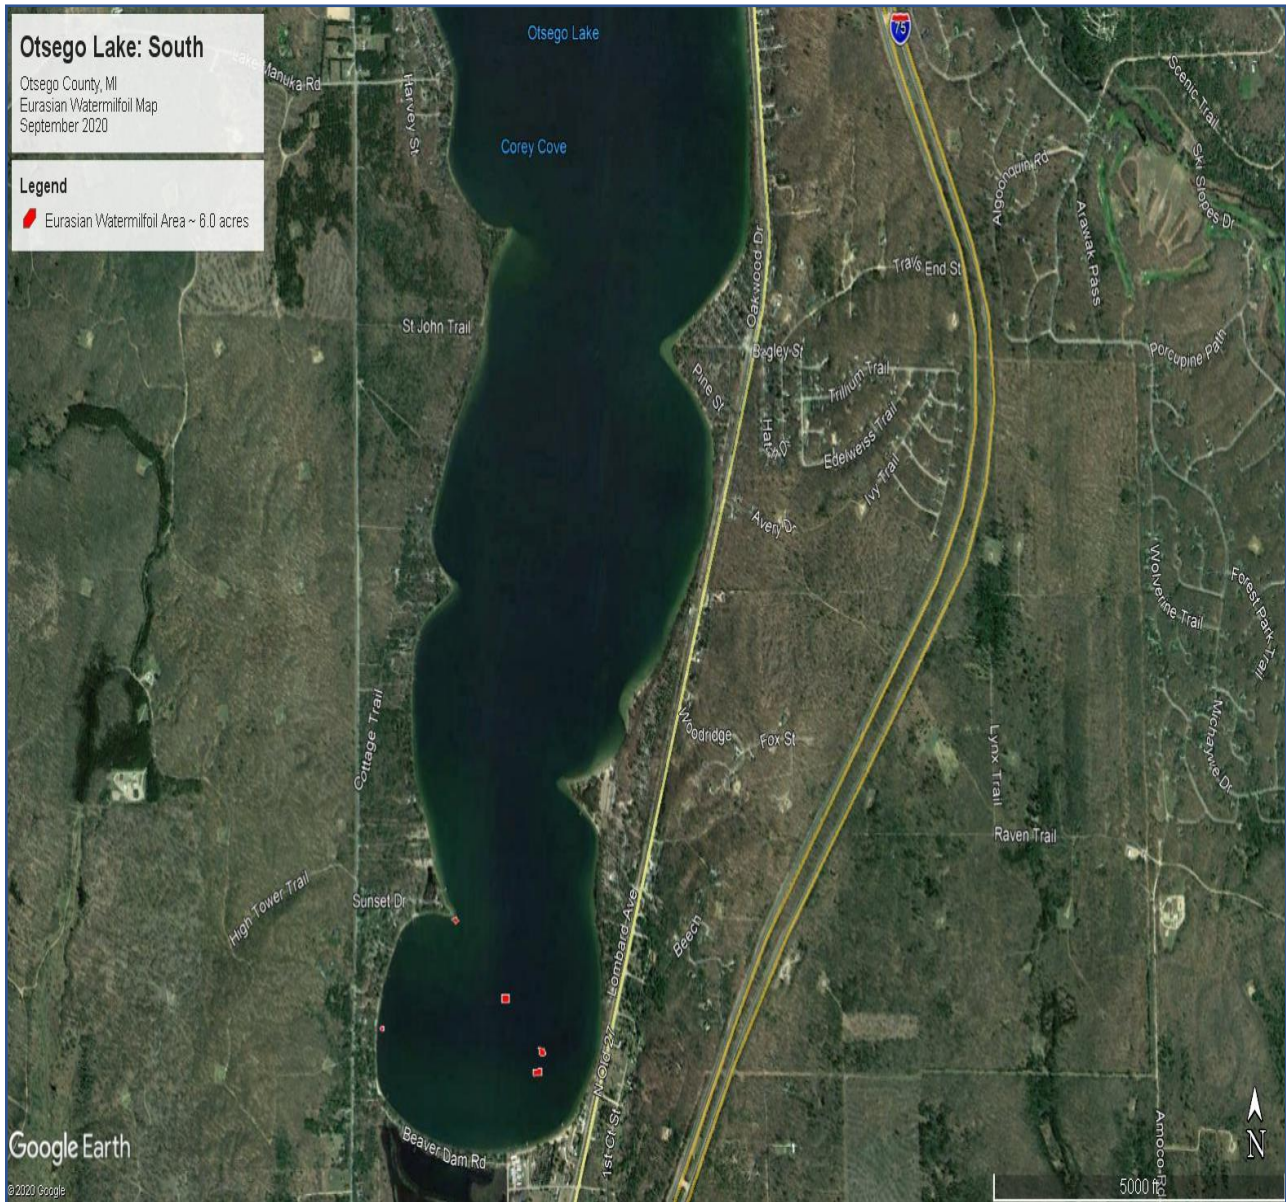
Figure 40. EWM distribution in Otsego Lake-South (September 9-11, 2020).

Approximately 12 acres of Eurasian Watermilfoil were found in Otsego Lake during the September 9-11, 2020 survey. An intensive management program is proposed below. Eurasian Watermilfoil growth in Otsego Lake is capable of producing dense surface canopies in shallow areas as well as in deeper waters due to the sometimes high light penetration. In addition, it could hybridize with the native northern watermilfoil and create a highly herbicide-resistant strain.

Systemic herbicides such as 2, 4-D and triclopyr are the two primary systemic herbicides used to treat milfoil that occurs in a scattered distribution. Fluridone (trade name, SONAR®) is a systemic whole-lake herbicide treatment that is applied to the entire lake volume in the spring and is used for extensive infestations. The objective of a fluridone treatment is to selectively control the growth of milfoil in order to allow other native aquatic plants to germinate and create a more diverse aquatic plant community. **Due to the scattered abundance of milfoil in Otsego Lake (given its size), the use of fluridone is not recommended. The use of other systemic herbicides such as triclopyr or 2,4-D that may be used for spot-treatments are recommended.**

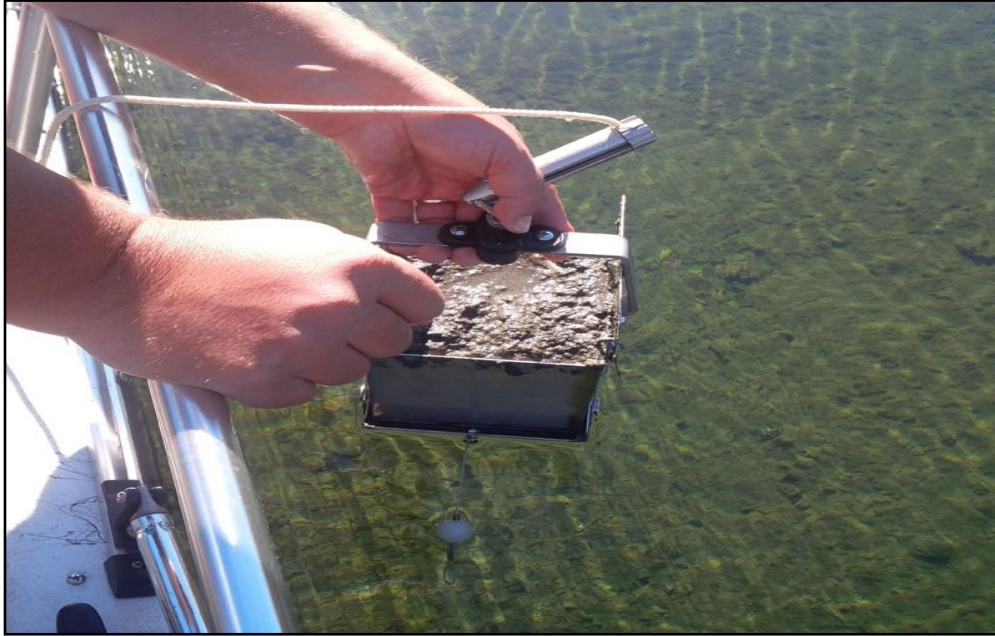
Figure 45. An Ekman hand dredge for sampling lake sediments.

Restorative Lake Sciences collected benthic (bottom) aquatic macroinvertebrate samples at five locations (Figure 44) using an Ekman hand dredge sampler (Figure 45) on September 9, 2020 (Table 18). Macroinvertebrate samples were placed in small plastic buckets and analyzed in the RLS wet laboratory within 48 hours after collection using a hard-plastic sorting tray, tweezers, and a Zeiss® dissection microscope under 1X, 3X, and 10X magnification power. Macroinvertebrates were taxonomically identified using a key from: “The Introduction to the Aquatic Insects of North America”, by Merritt, Cummings, and Berg (2008) to at least the family level and genus level whenever possible. All macroinvertebrates were recorded including larval or nymph forms, mussels, snails, worms, or other “macro” life forms.

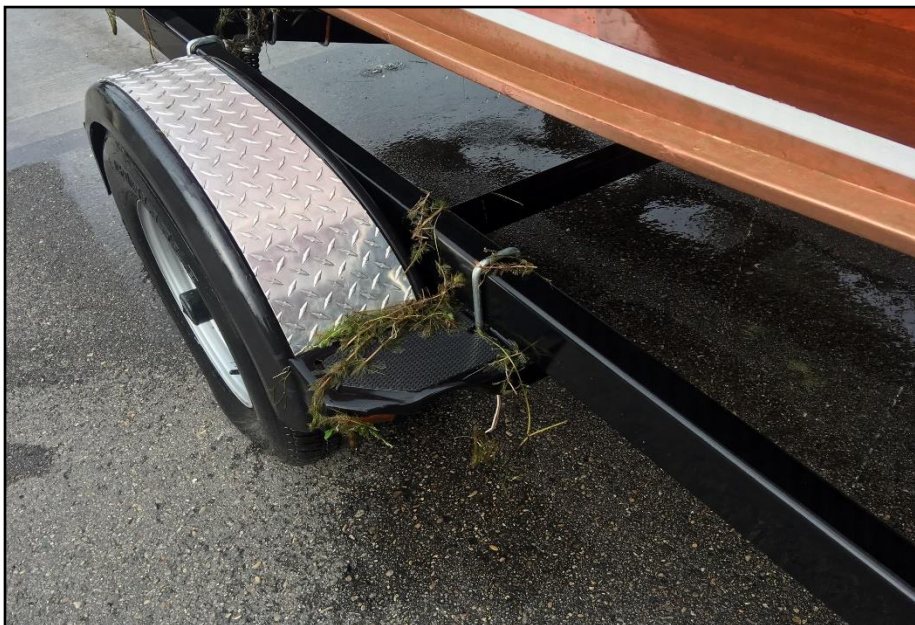
Figure 47. An aquatic hitchhiker (milfoil) on a boat trailer.

The first ingredient to successful prevention of unwanted transfers of exotic species to Otsego Lake is awareness and education (Figures 46 and 47). The exotic species of concern have been listed in this report. Other exotic species on the move could be introduced to the riparians around Otsego Lake through the use of a professionally developed educational newsletter or through public workshops on the health of the Otsego Lake ecosystem.

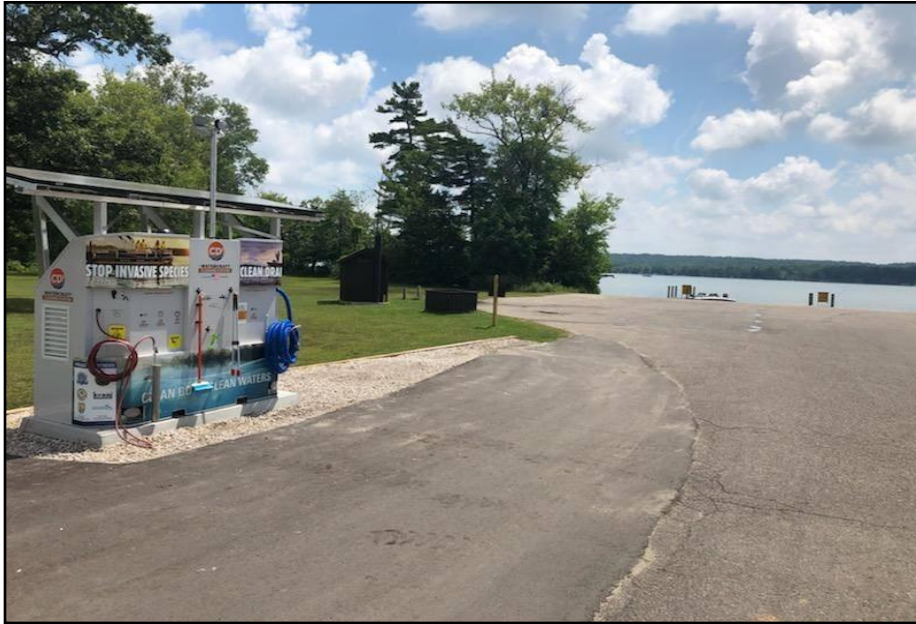
Figure 48. A public boat washing station on Higgins Lake, Michigan.

Recently, MSU partnered with EGLE to study the various forms of boat washing stations (including the innovative CD3 units) on lakes to analyze effectiveness of invasive removal, behavior patterns and preference for use, and short and long-term cost effectiveness of each system. This will assist in the placement of specific types of wash stations around specific portals of entry around lakes. Boat washing stations and invasive species prevention signs are recommended at all public entry sites where practical, especially since enforcement is not required and is lacking.

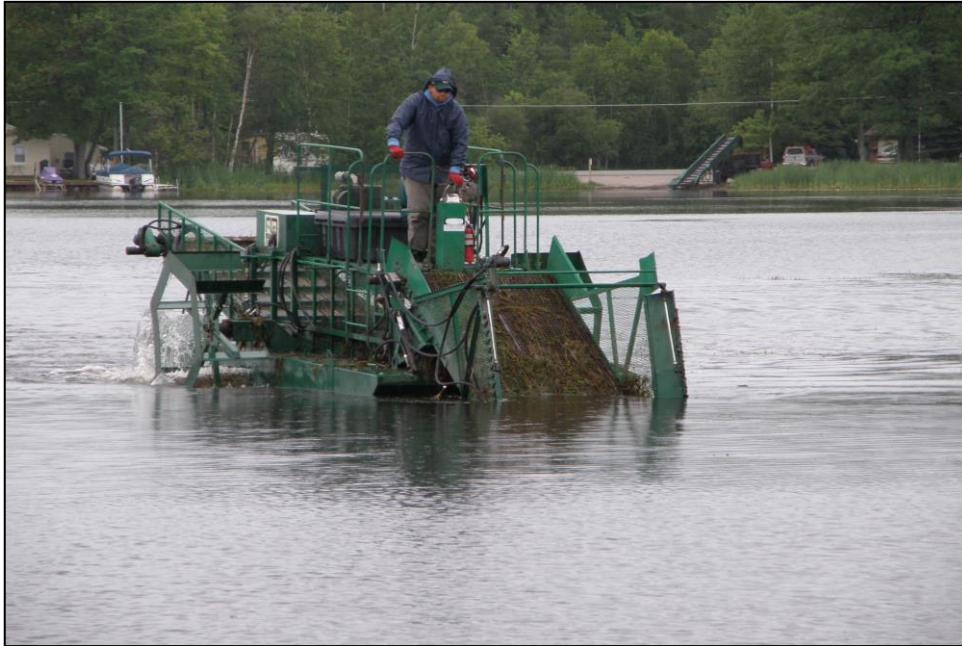
Figure 54. A mechanical harvester used to remove aquatic plants.

Mechanical harvesting involves the physical removal of nuisance aquatic vegetation with the use of a mechanical harvesting machine (Figure 54). The mechanical harvester collects numerous loads of aquatic plants as they are cut near the lake bottom. The plants are off-loaded onto a conveyor and then into a dump truck. Harvested plants are then taken to an offsite landfill or farm where they can be used as fertilizer. Mechanical harvesting is preferred over chemical herbicides when primarily native aquatic plants exist, or when excessive amounts of plant biomass need to be removed.

Mechanical harvesting is usually not recommended for the removal of Eurasian Watermilfoil since the plant may fragment when cut and re-grow on the lake bottom. Additionally, it is often not practical for very large lakes, given the long transfer times to offload harvested vegetation. Due to the distribution of invasives in open water areas, mechanical harvesting is not recommended or needed for Otsego Lake.

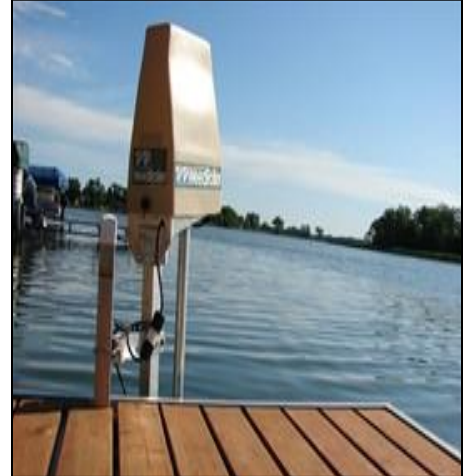
Figure 56. A Weed Roller.

The use of benthic barrier mats (Figure 55) or Weed Rollers (Figure 56) have been used to reduce weed growth in small areas such as in beach areas and around docks. The benthic mats are placed on the lake bottom in early spring prior to the germination of aquatic vegetation. They act to reduce germination of all aquatic plants and lead to a local area free of most aquatic vegetation. Benthic barriers may come in various sizes between 100-400 feet in length.

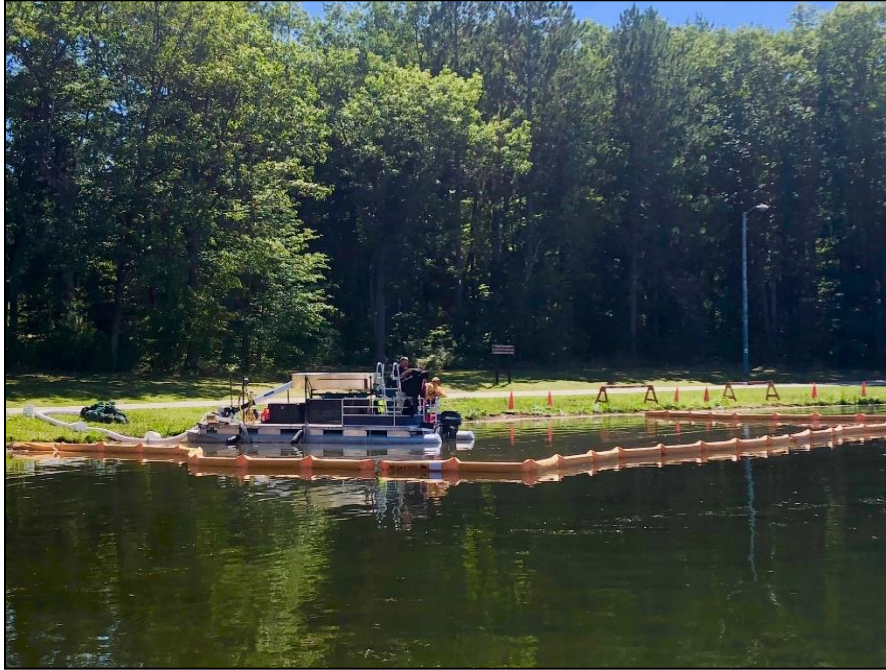
Figure 57. A DASH boat used in a lake for aquatic plant removal.

Suction harvesting via a Diver Assisted Suction Harvesting (DASH) boat (Figure 57) involves hand removal of individual plants by a SCUBA diver in selected areas of lake bottom with the use of a hand-operated suction hose. Samples are dewatered on land or removed via fabric bags to an offsite location. This method is costly on a large scale and so it used on a spot-removal basis or in small areas. It has been used to remove nuisance invasive aquatic vegetation in inland lakes and requires a joint permit with EGLE and the U.S. Army Corps of Engineers (USACE).

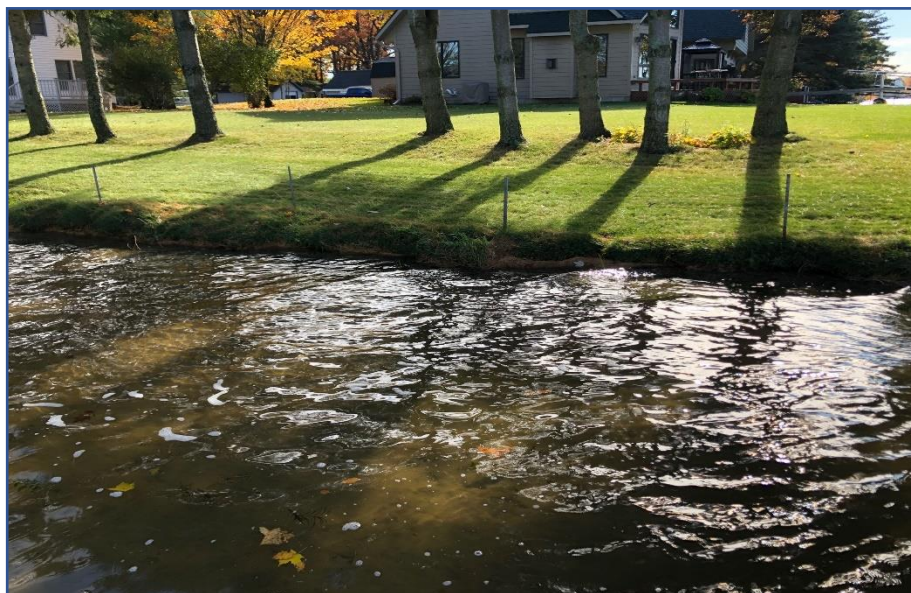
Figure 83. Erosion Site #28

28	Road end (Stonewood St), failing concrete seawall. Road end is 3' higher than lake effecting seawall
29	Undercut grass bank in canal.
30	Dock put in sand bank 30' long 3 foot high.
31	Wild rice at canal entrance
32	Undercut white pine and sand beach 3' high
33	80' undercut bank
34	Water control and overflow structure for marsh. (Old pike fish hatchery?)
35	40' apparent ice push damage
36	80' sand area, possible seaplane launch
37	200' undercut grass
38	800' unprotected sand shoreline, slow erosion
39	300' long 18" tall sand beach
40	100' beach area 2' tall signs of sheet erosion
41	Rock riprap failing seawall 60'
42	Launch site with wood seawall and cover
43	Well protected native shoreline
44	60' slumping sand beach between seawalls
45	Failing concrete wall by canal
46	Undermined failing rock riprap seawall
47	Road end with 3' high sand erosion
48	Undercut wooded bank in canal
49	Sand fill with not much vegetation, eroding into lake

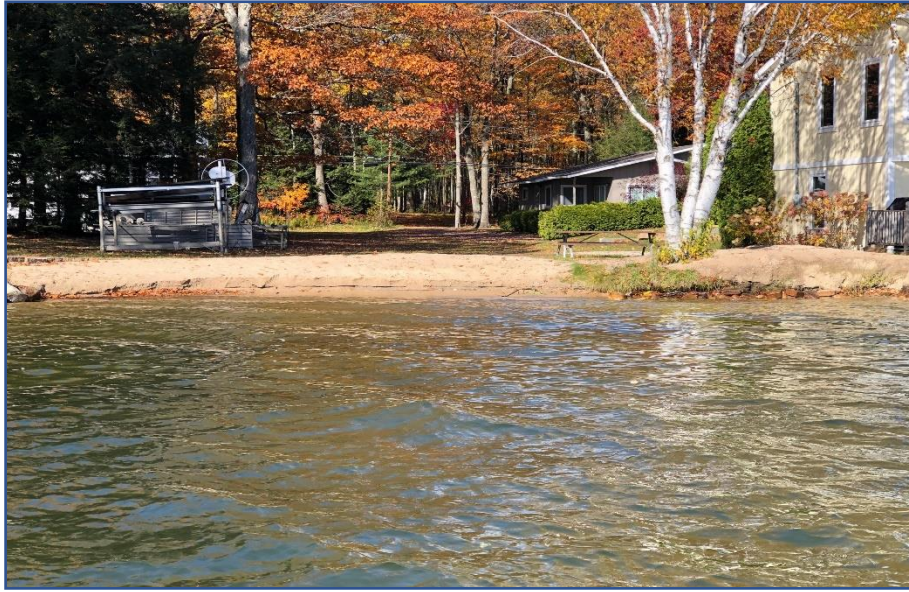
Figure 98. Erosion Site #43 (No erosion present-excellent buffer).

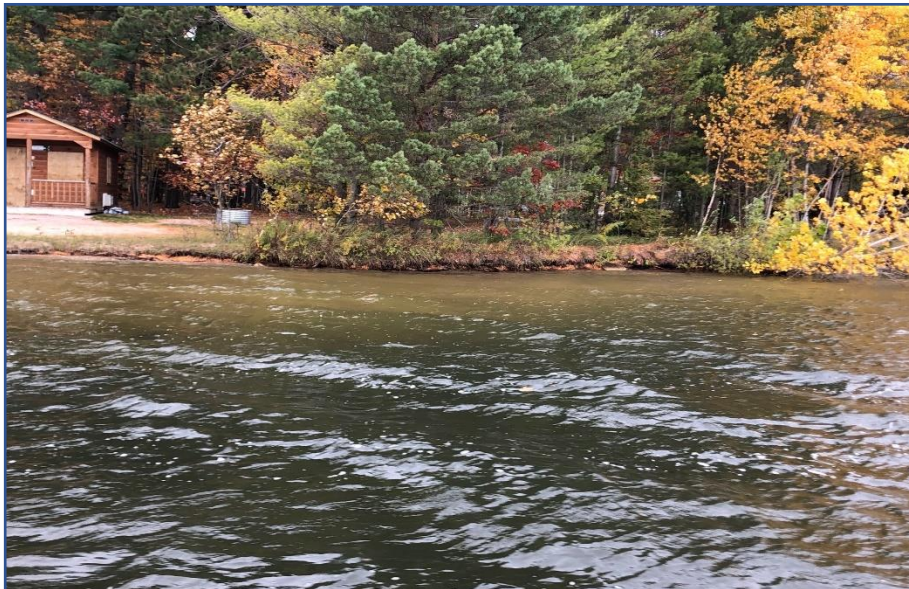
Figure 105. Erosion Site #50

50	75' of ice lift damage
51	100' of 18" tall sand cut bank
52	80' undercut grass area adjacent to township boat launch
